2 MM&T - LOW COST PRODUCTION/INSTALLATION OF
URETHANE LEADING EDGE GUARDS ON ROTOR BLADES.

10 M. L./White
A. L./Belbruno

Kaman Aerospace Corporation
Old Windsor Road
Bloomfield, Connecticut 06002

9 Final Report, 23 Aug 1979 - 9 Dec 1980

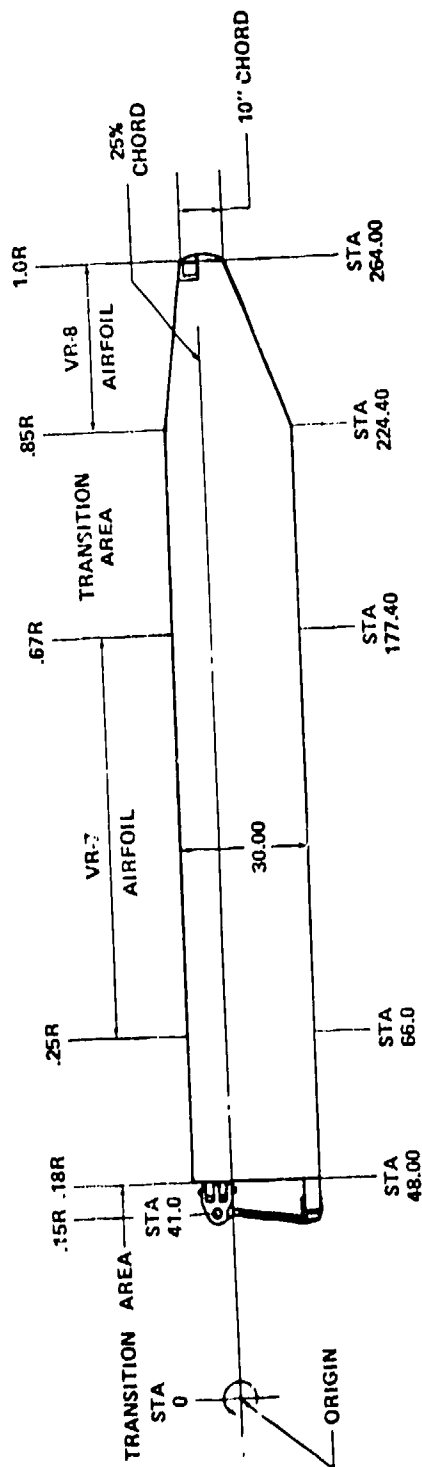
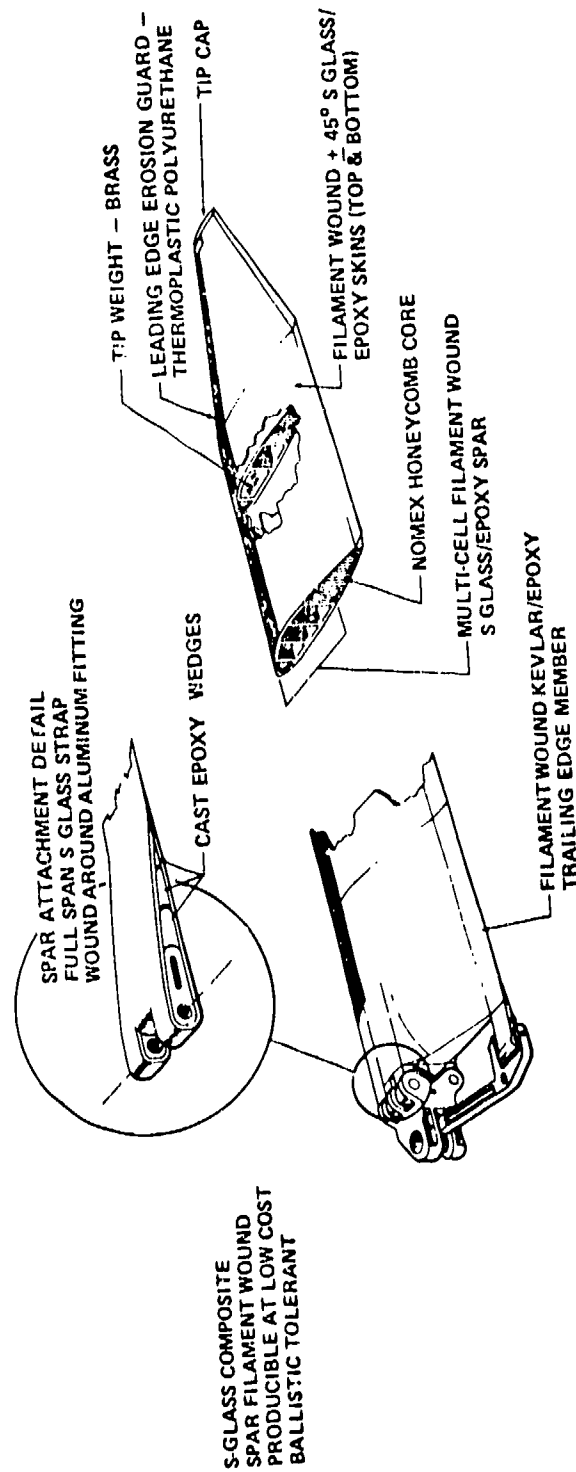
Figure 1. AH-1Q/S blade configuration.

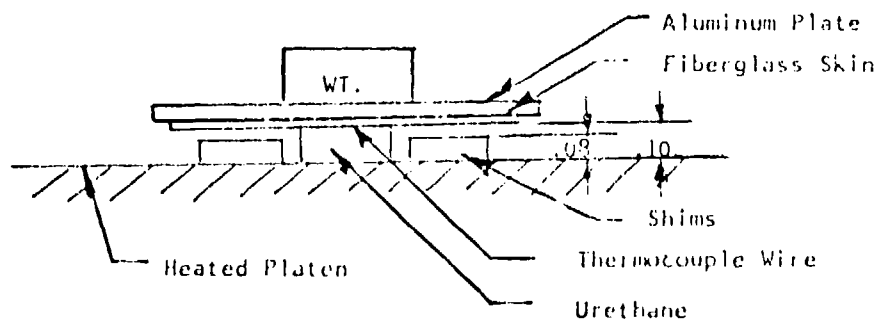
Figure 2. Molding urethane strip to fiberglass under controlled temperature and pressure.

Test Specimens. All specimens were made with the same surface preparation and process planned for the actual rotor blade spar. A panel of glass fiber impregnated with the same epoxy resin compound used for the spars was precured with a nylon peel ply on one surface. The nylon was removed immediately prior to the application of the DAG to provide a clean, roughened surface. The DAG was spray applied to the required thickness followed by an oven dry. Over this, the epoxy primer was spray applied and allowed to cure overnight. The panel was cut into smaller 3 x 8-inch panels which were brush coated with the Estane/MEK adhesive as needed and allowed to air dry for 2 hours minimum for evaporation of solvent. The Estane was cut into 1 x 8-inch strips and molded to the 3 x 8-inch fiberglass panels on the surface of a laboratory press preset to the desired temperature, with the proper weight placed on top to maintain constant pressure as the urethane softened and flowed. When molding, the Estane was reinforced by a ply of nylon to eliminate stretching while testing. The material was reduced in thickness by 20%, starting at .10 inch and molding down to .08 inch. Figure 2 illustrates the molding setup. One specimen

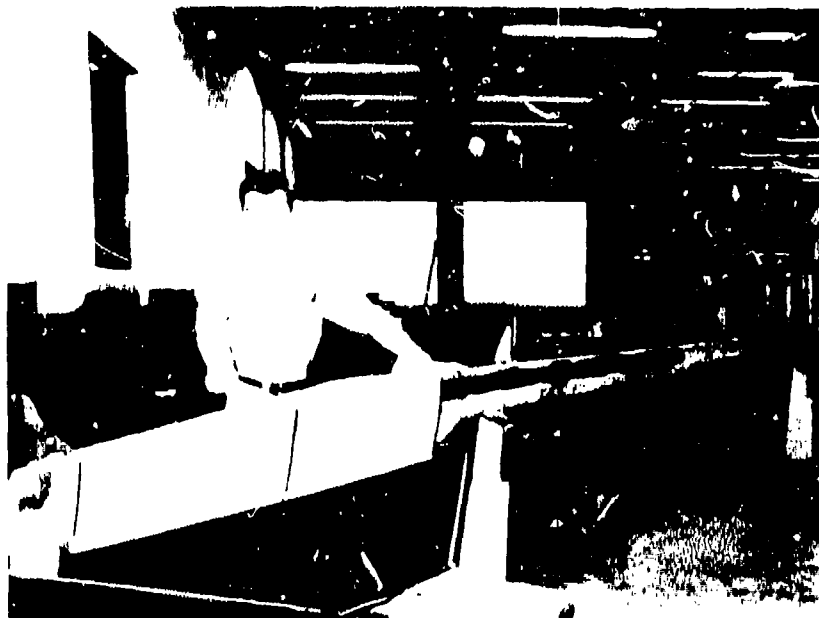
Figure 4. Female mold made on blade S/N 1010.

The leading edge surface of blade S/N 1010 was built up with tooling wax in the area mentioned above to simulate boot thickness. Over this, the female plaster mold seen in Figure 4 was made, and in this, the male epoxy master was made.

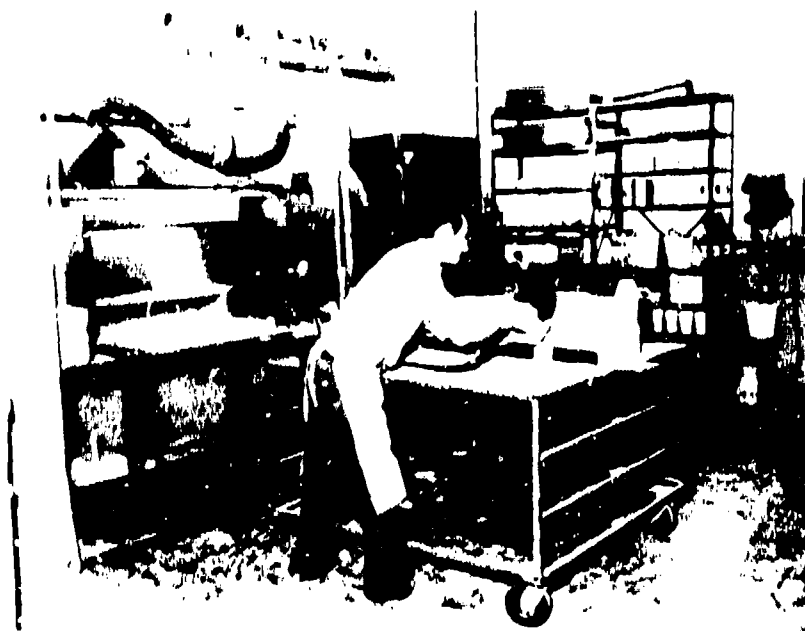
Figure 5. Metal spraying the male mandrel.

Figures 5, 6, 7, and 8 show the mold in the various stages: spraying the metal, locating the tubing, pouring the resin, and curing after pouring. In Figure 7, flexible hoses are seen attached to the copper tubing, through which cooling water is run to control exothermic action of the resin mass.

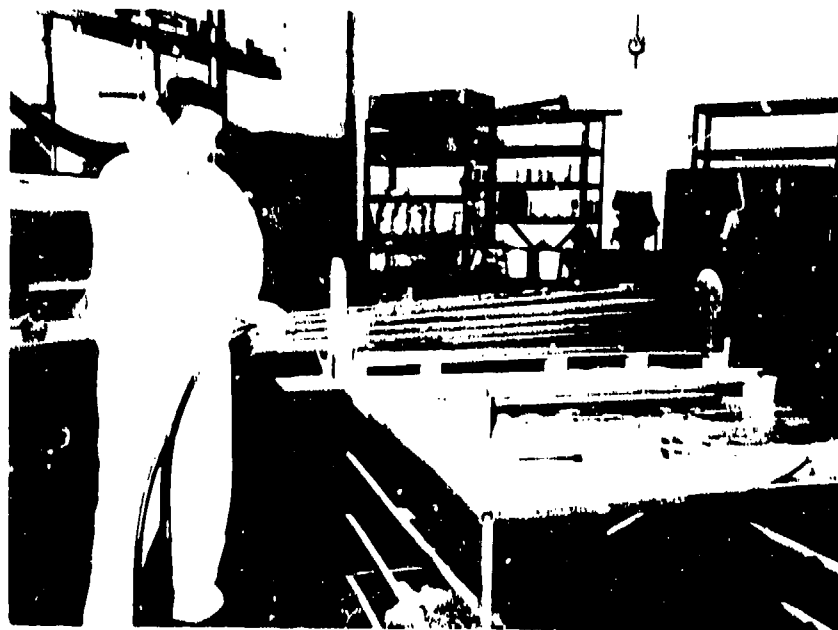
Figure 6. Mandrel with copper tubes in place prior to pouring resin.

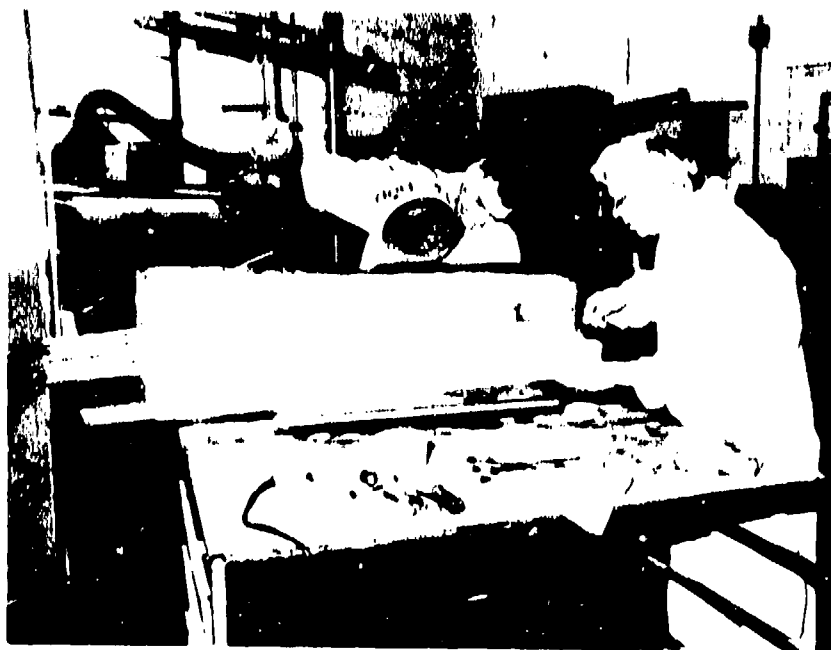
Figure 7. Pouring resin for the mold.

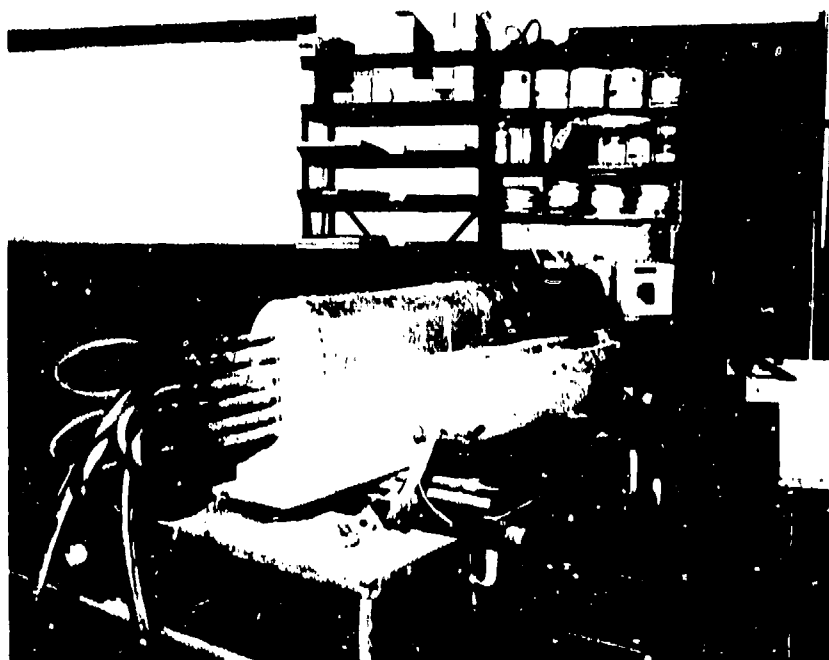
Figure 8. Mold being cured after pouring.

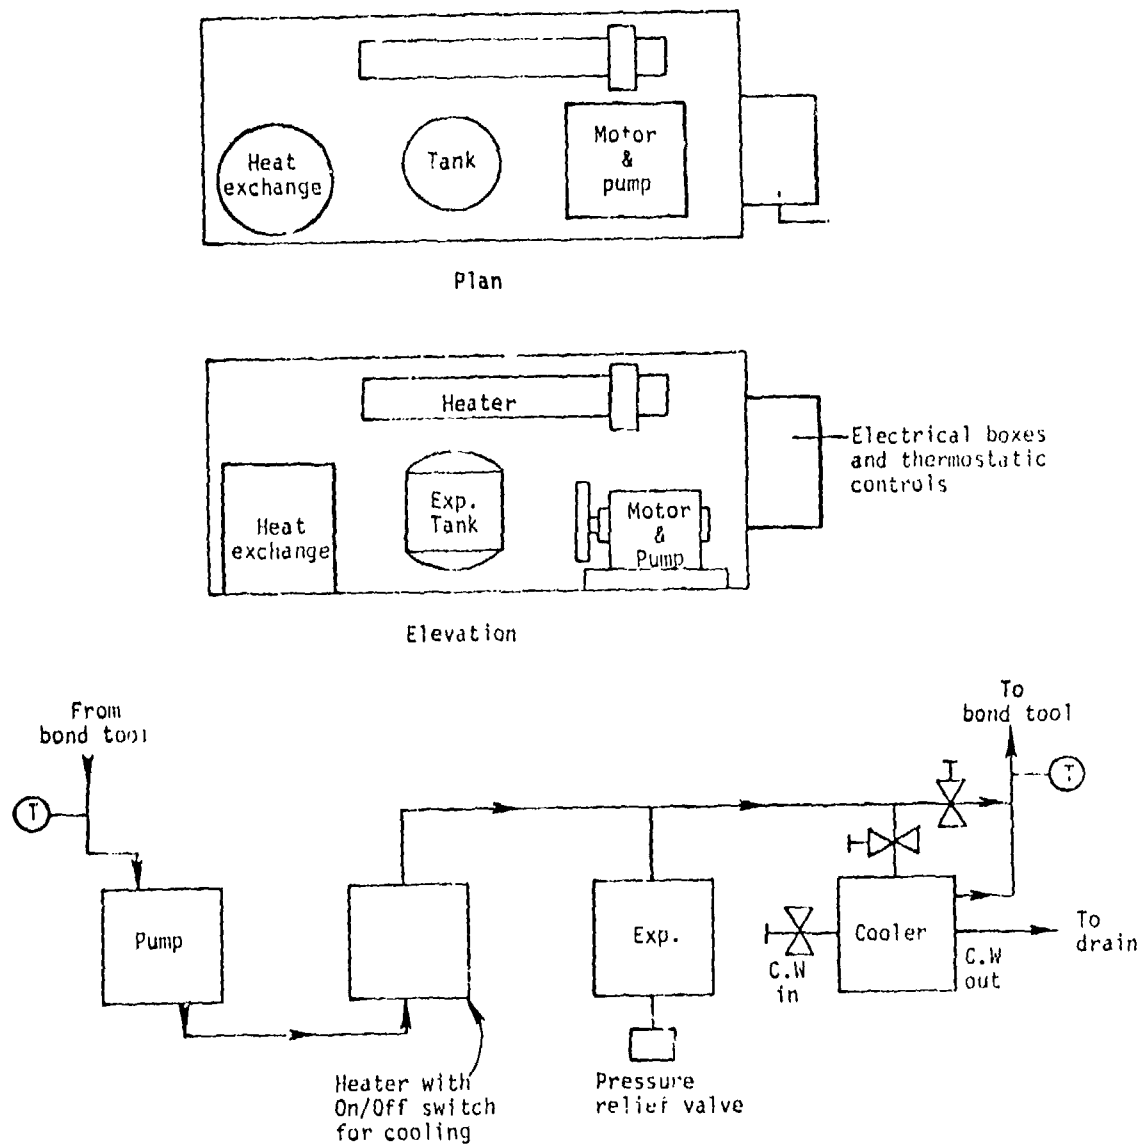
Figure 11. Layout and schematic of heating/cooling unit for boot molding fixture.

Figure 11 is a layout and schematic of the heating/cooling unit of the bond fixture.

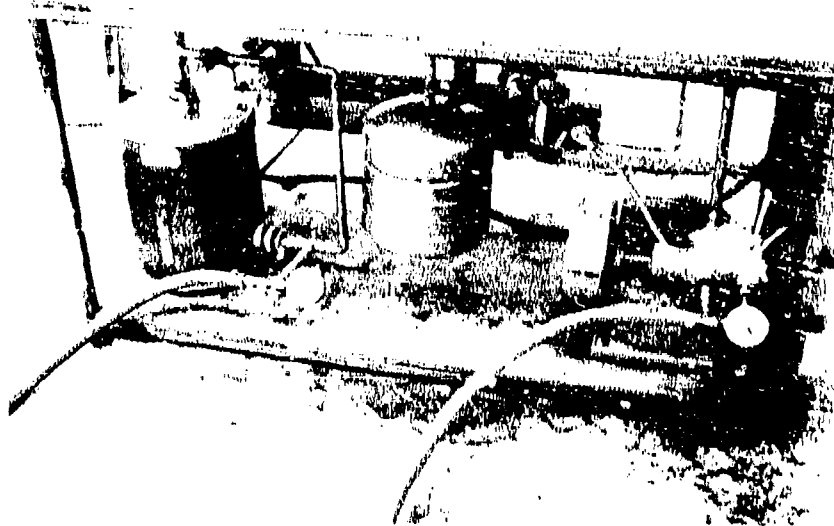
Figure 12. Heating/cooling unit after assembly.

Figure 12 shows the assembled unit and figures 13 and 14 show the unit connected to the tool. The unit is completely sealed for pressurization and incorporates pressure relief valves. Thus, hot oil or water under pressure to obtain temperatures above the fluid boiling point at atmospheric pressure may be circulated. In this program, all heating was obtained with pressurized hot water circulated through the copper tubing. To cool the mold, the water is rerouted through the heat exchanger, seen on the left side of the unit, and cooled while being recirculated.

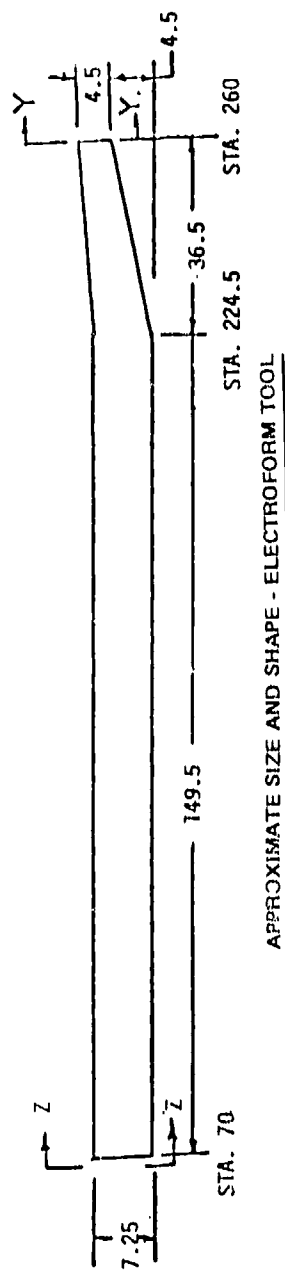
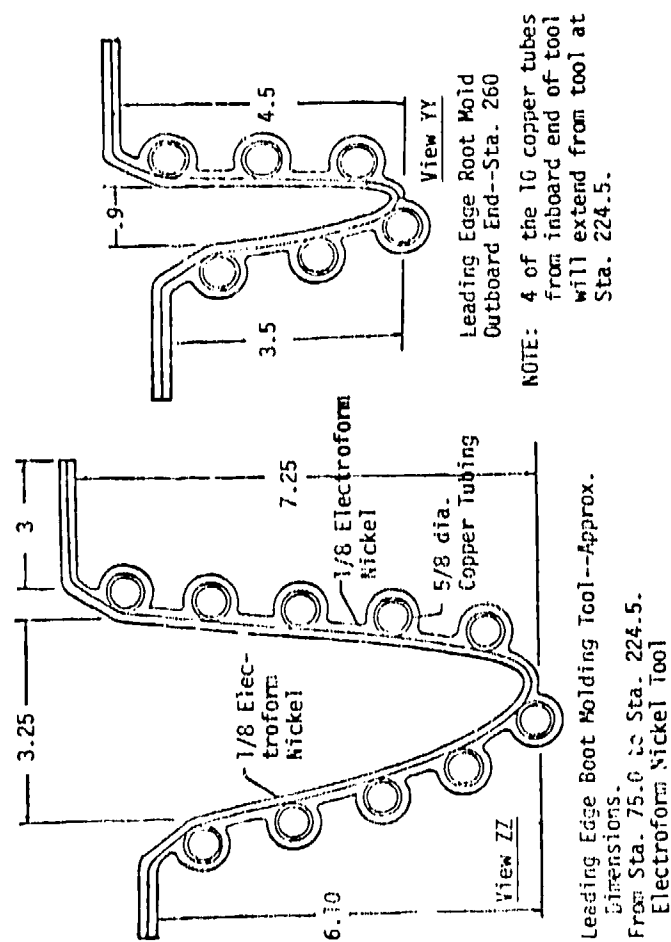
APPROXIMATE SIZE AND SHAPE - ELECTROFORM TOOL

Figure 19. Proposed electroformed nickel mold.

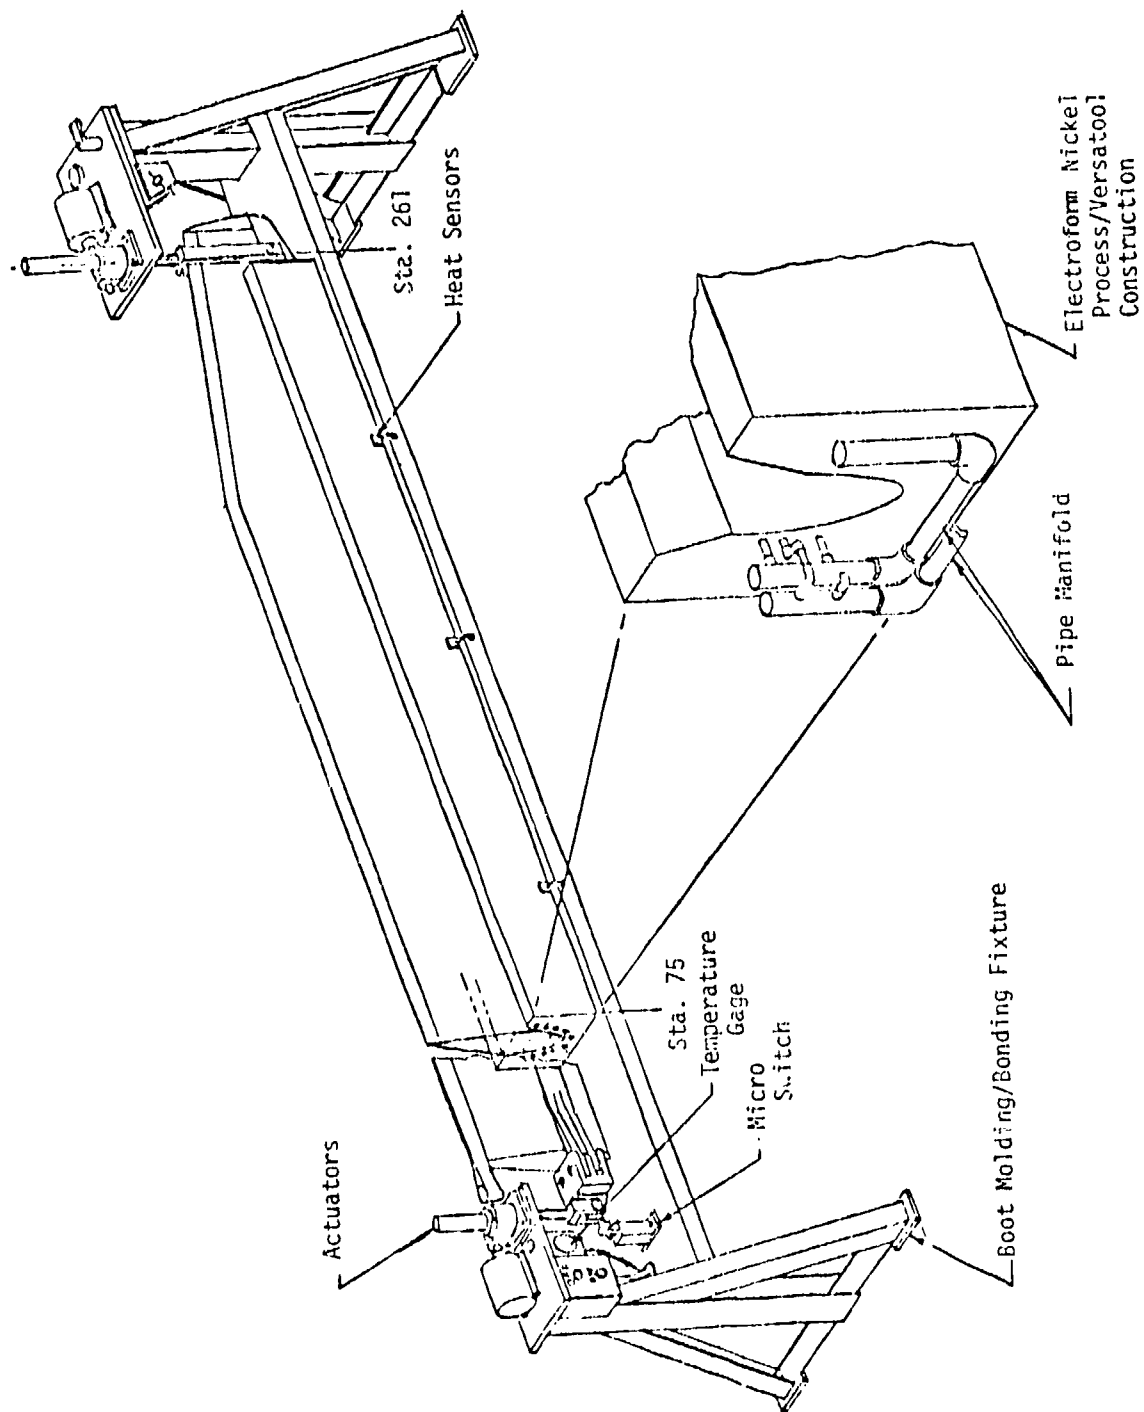
Figure 20. Tool design concept.
